LEARNING FROM THE

No one knows with certainty what mix of factors brought down two of the world's most sophisticated passenger jets. The final accident reports from the Lion Air and Ethiopian Airlines crashes are still being drafted.

Jan Tegler looks at how the crews might have been able to save their aircraft from all that was working against them.

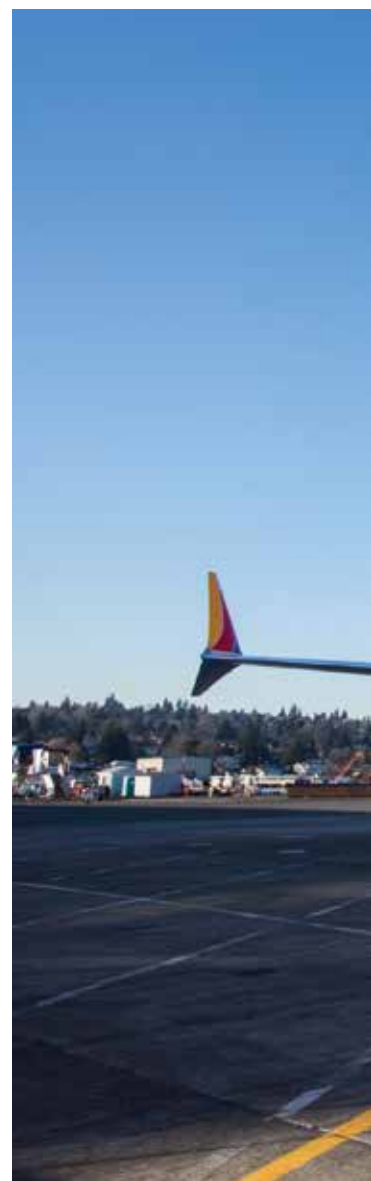
▼ **An angle-of-attack** sensor is the bottom piece of metal protruding from the left of this Boeing 737 MAX 8. Faulty readings from such a sensor were among the factors in two 737 MAX crashes.

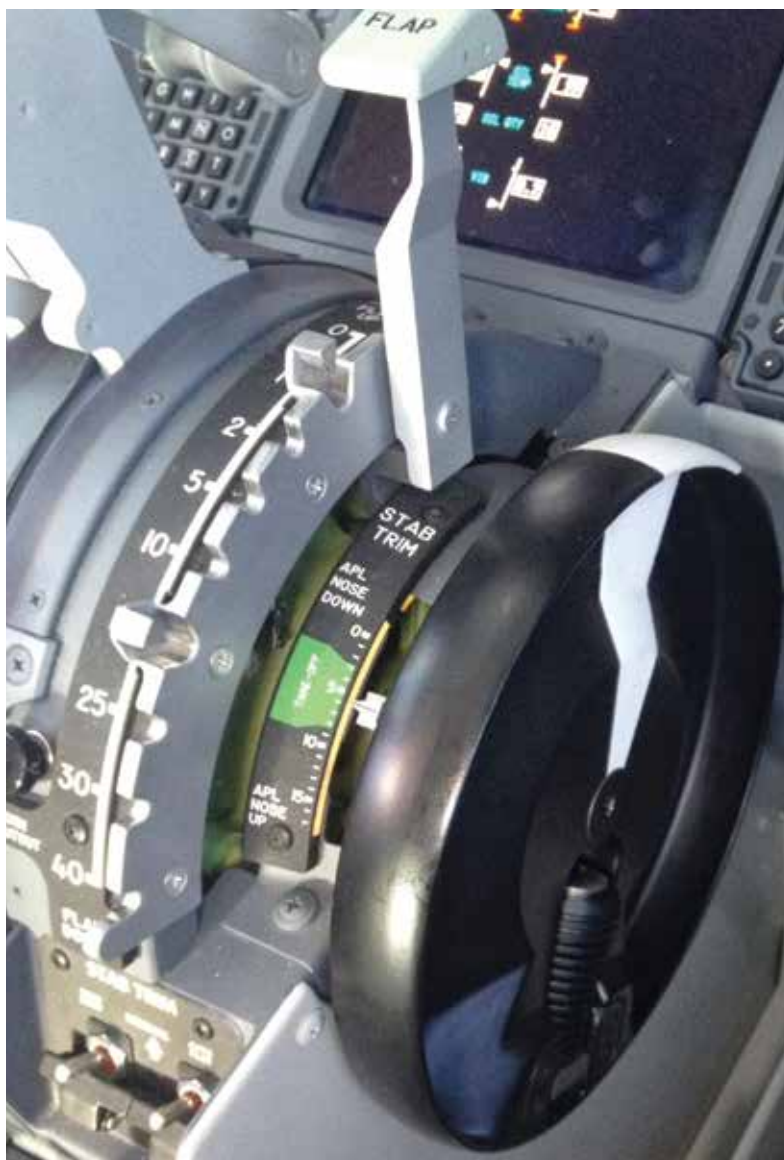
▲ A Boeing 737 MAX throttle trim wheel. The autopilot stab trim cutout switches are at lower left.

What he means is that I should turn off the power to the electric motors that drive the jackscrew attached to the horizontal stabilizer, the control surface that MCAS was errantly rotating upward.

We can now take manual control of the horizontal stabilizer by winding two large trim wheels on either side of the throttle pedestal. If a malfunctioning motor or faulty wiring had caused the runaway trim, we have now removed these factors

Turning the wheel forward trims the nose up: “Give me forward turns nose-up trim. Now give me two more turns,” Menza says.
